**MARYLAND HISTORICAL TRUST  
DETERMINATION OF ELIGIBILITY FORM**

Property Name: Croom Historic District Inventory Number: P.G. 86A-27  
Address: Croom Road in vicinity of Duley Station  
Road and St. Thomas Church Road. City: \_\_\_\_\_ Zip Code: \_\_\_\_\_  
County: Prince George's USGS Topographic Map: Upper Marlboro, Brandywine  
Owner: Various Is the property being evaluated a district? X yes  
Tax Parcel Number: \_\_\_\_\_ Tax Map Number: \_\_\_\_\_ Tax Account ID Number: \_\_\_\_\_  
Project: Lake Marlton L.P. (East Marlton) Agency: U.S. Army, Corps of Engineers, Baltimore District.  
Site visit by MHT Staff: X no \_\_\_\_\_ yes Name: \_\_\_\_\_ Date: \_\_\_\_\_  
Is the property located within a historic district? X yes \_\_\_\_\_ no

Croom Historic District  
P.G. 86A-27

Continuation Sheet No. 1

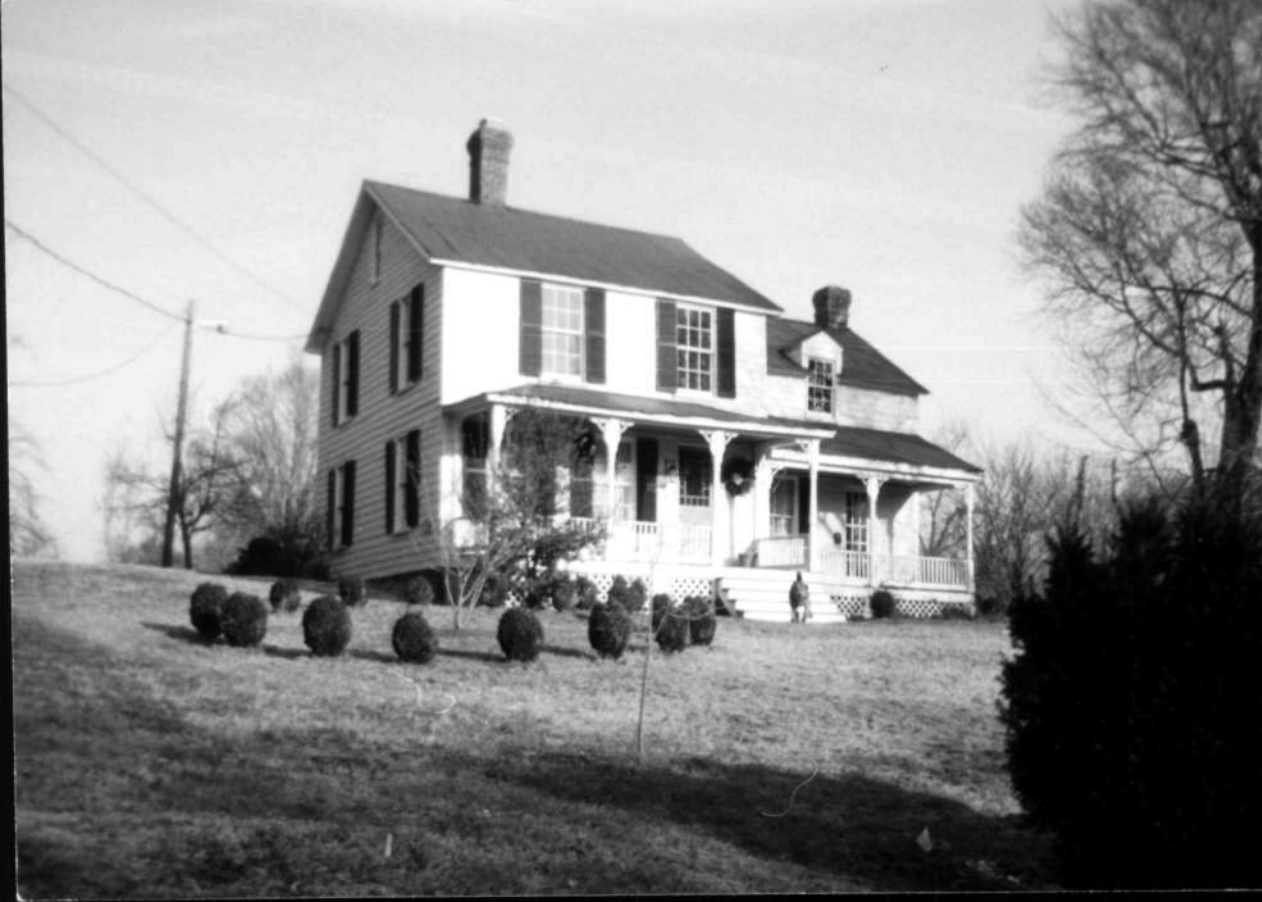
24 of 32

Original Survey Number 37, Blanche Ogle House, 9912 Croom Rd. (C),  
View to North.

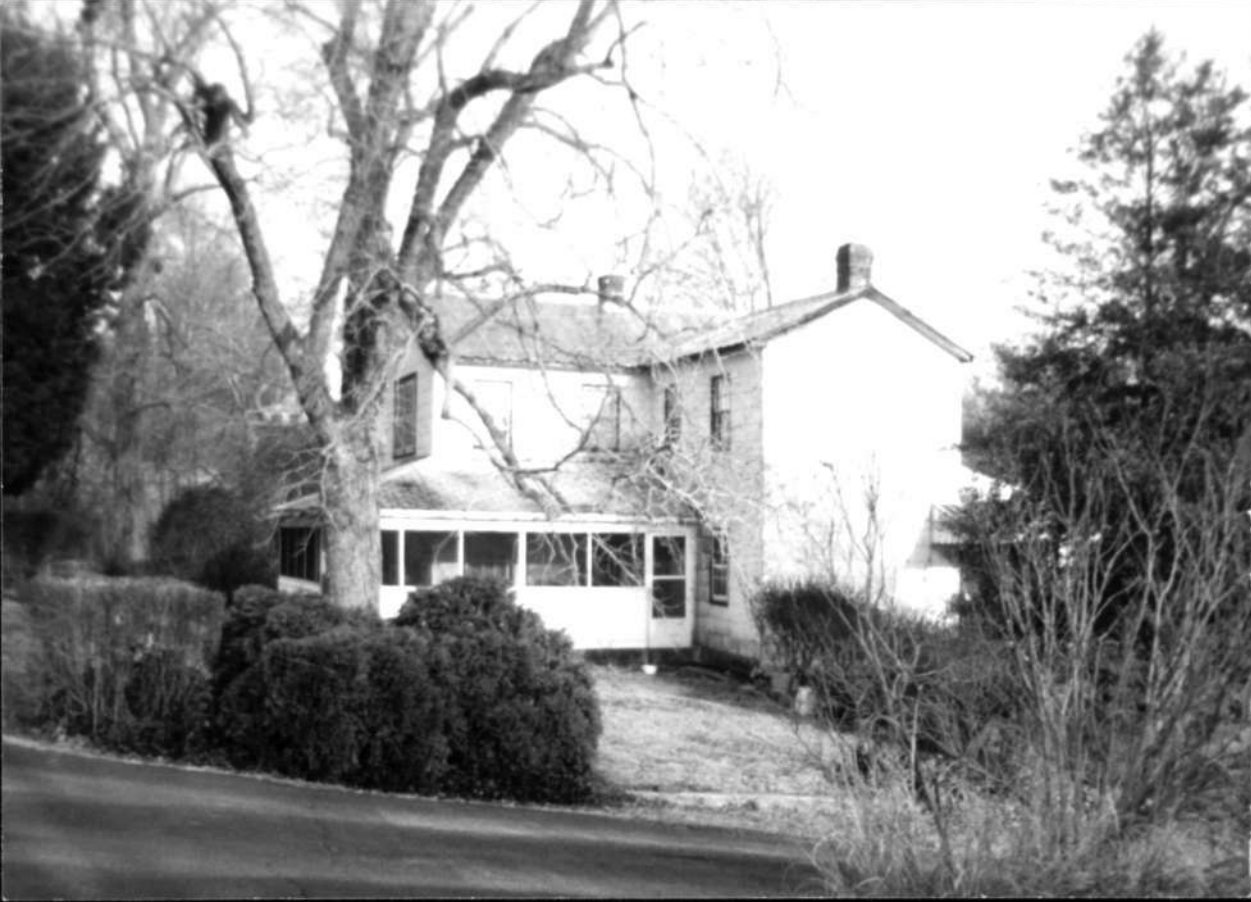
25 of 32

Original Survey Number 38, William F. Figuerre House,  
10000 Croom Rd. (C), View to West,

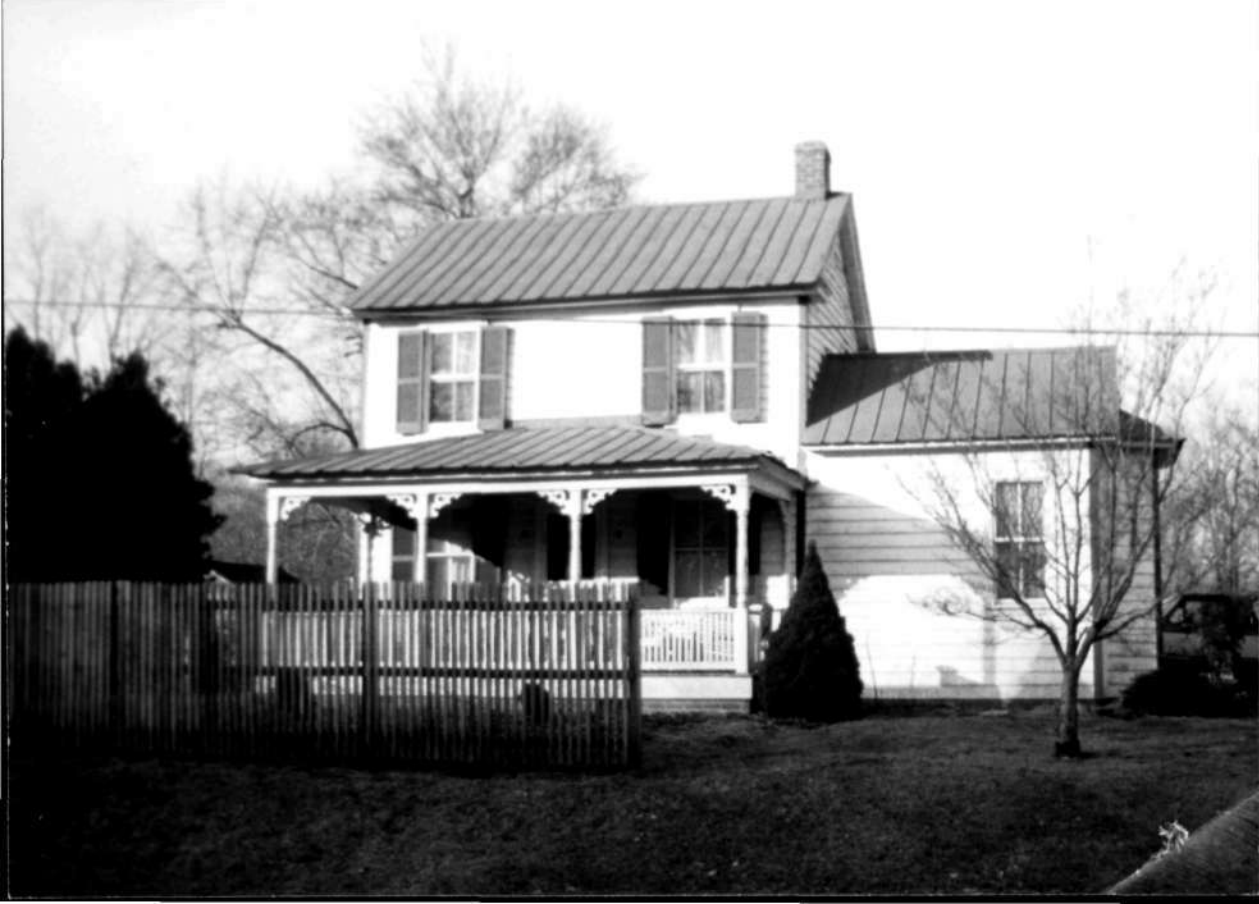
27 of 32

Original Survey Number 41, Arthur Duley House,  
10109 Croom Rd. (C), View to West

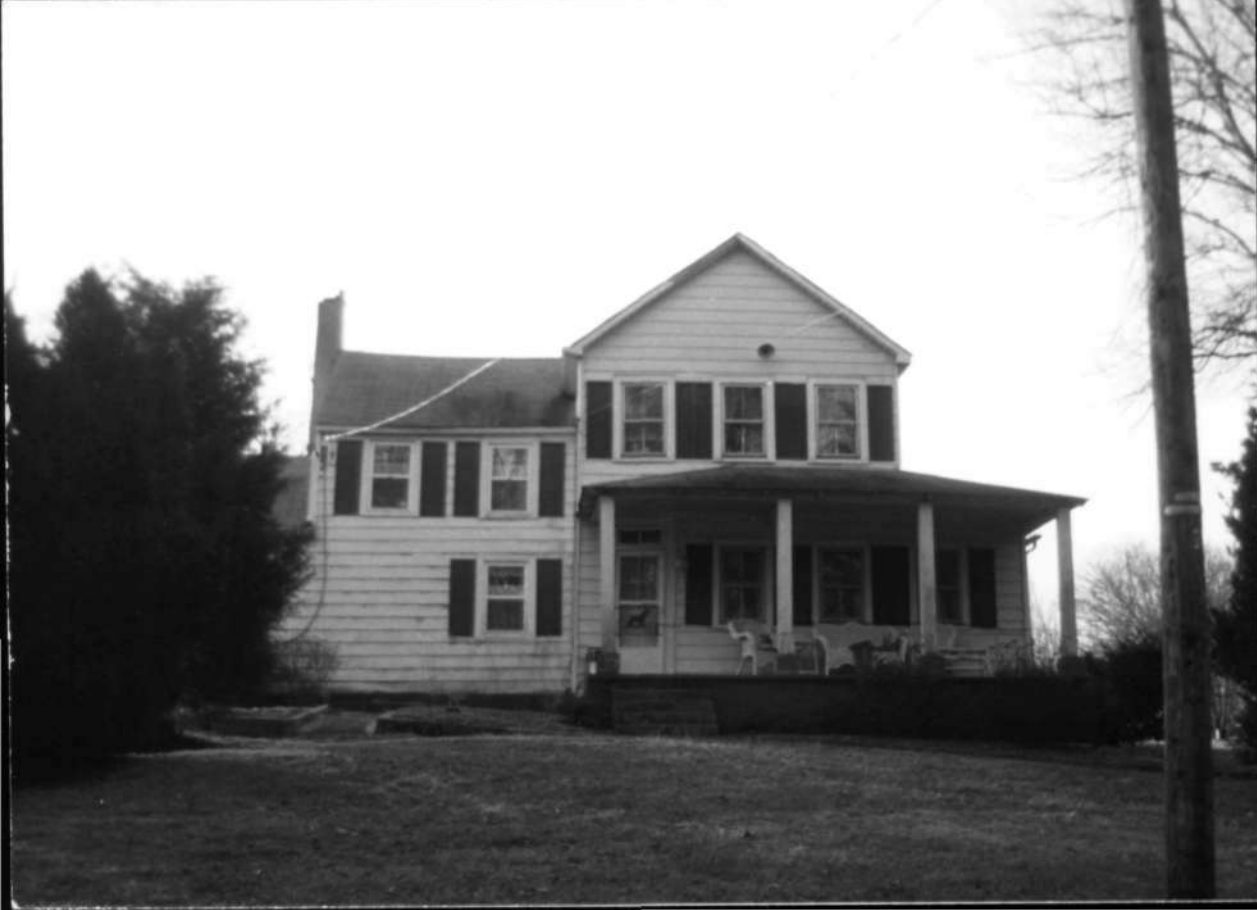
28 of 32

Original Survey Number 43, P.G. 86A-24, Croom Industrial School,  
14401 St. Thomas Church Rd. (C), View to South,

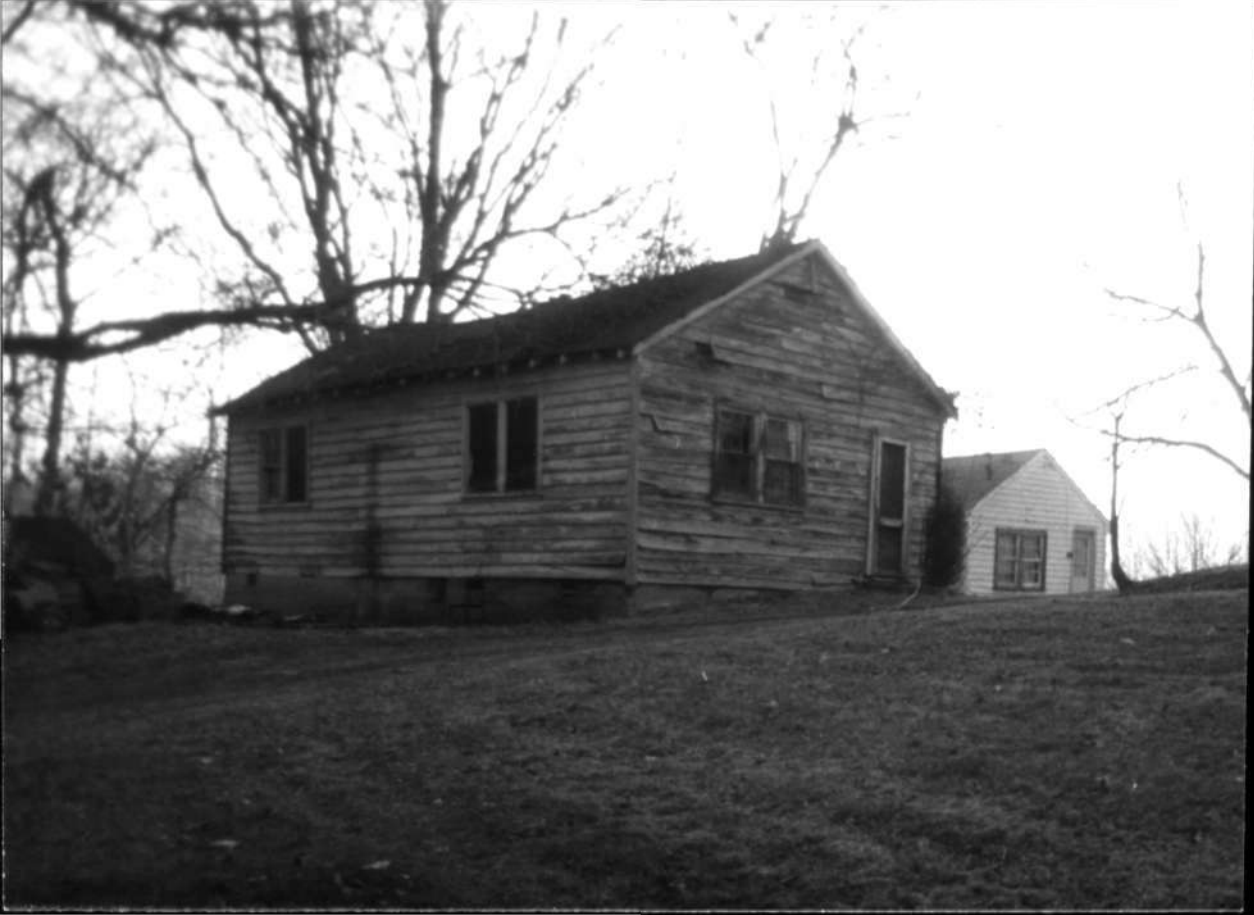
29 of 32

Original Survey Number 43, PG 86A-24, Croom Industrial School  
outbuildings, 14401 St. Thomas Church Rd. (C), View to East.

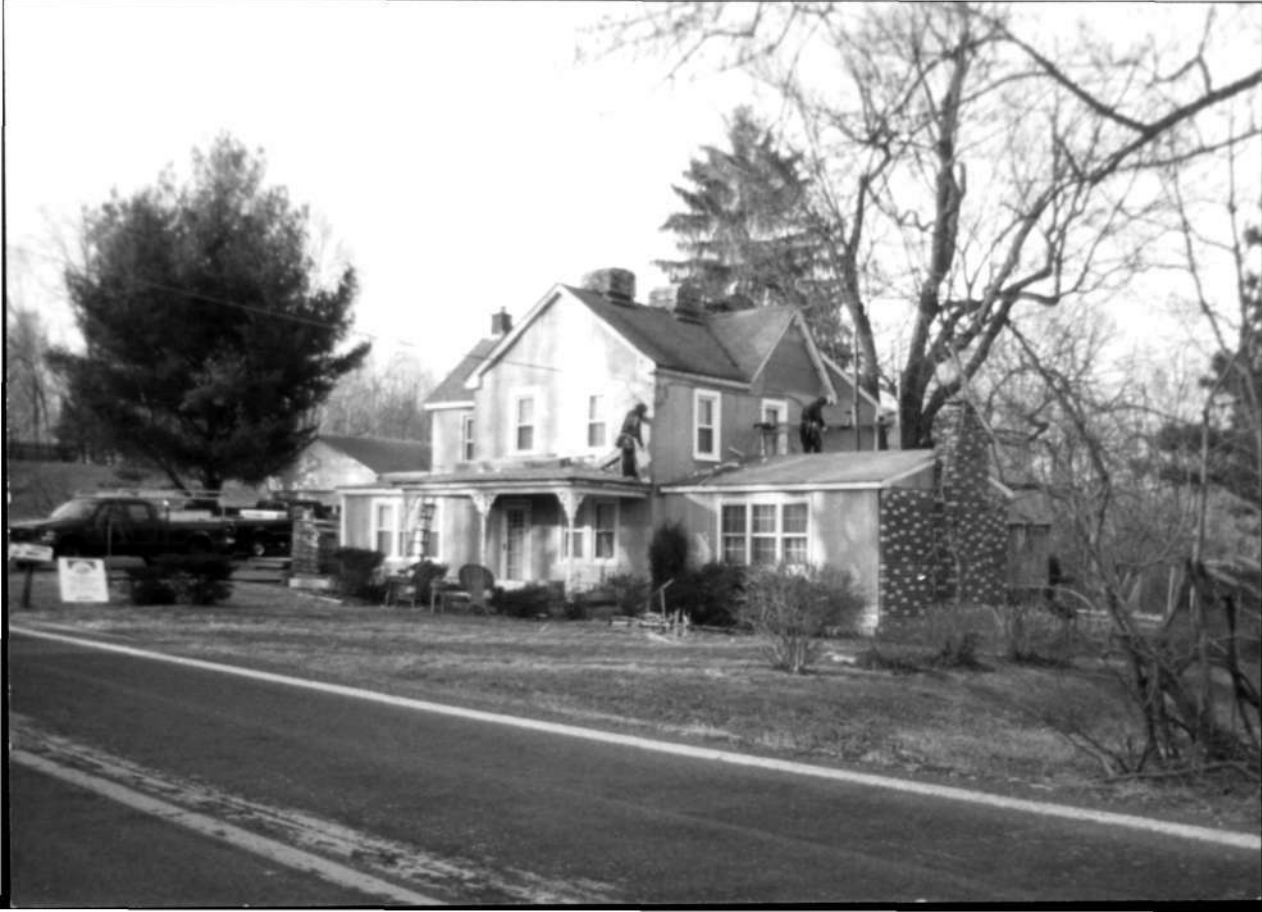
30 of 32

Original Survey Number 45, Robert N. Rollins House,  
10401 Croom Rd. (C), View to Southwest
